# STUDY OF CRACK INITIATION PHENOMENA ASSOCIATED WITH STRESS CORROSION OF ALUMINUM ALLOYS

FINAL SUMMARY REPORT

ALCOA RESEARCH LABORATORIES  
NEW KENSINGTON, PA

October 6, 1969

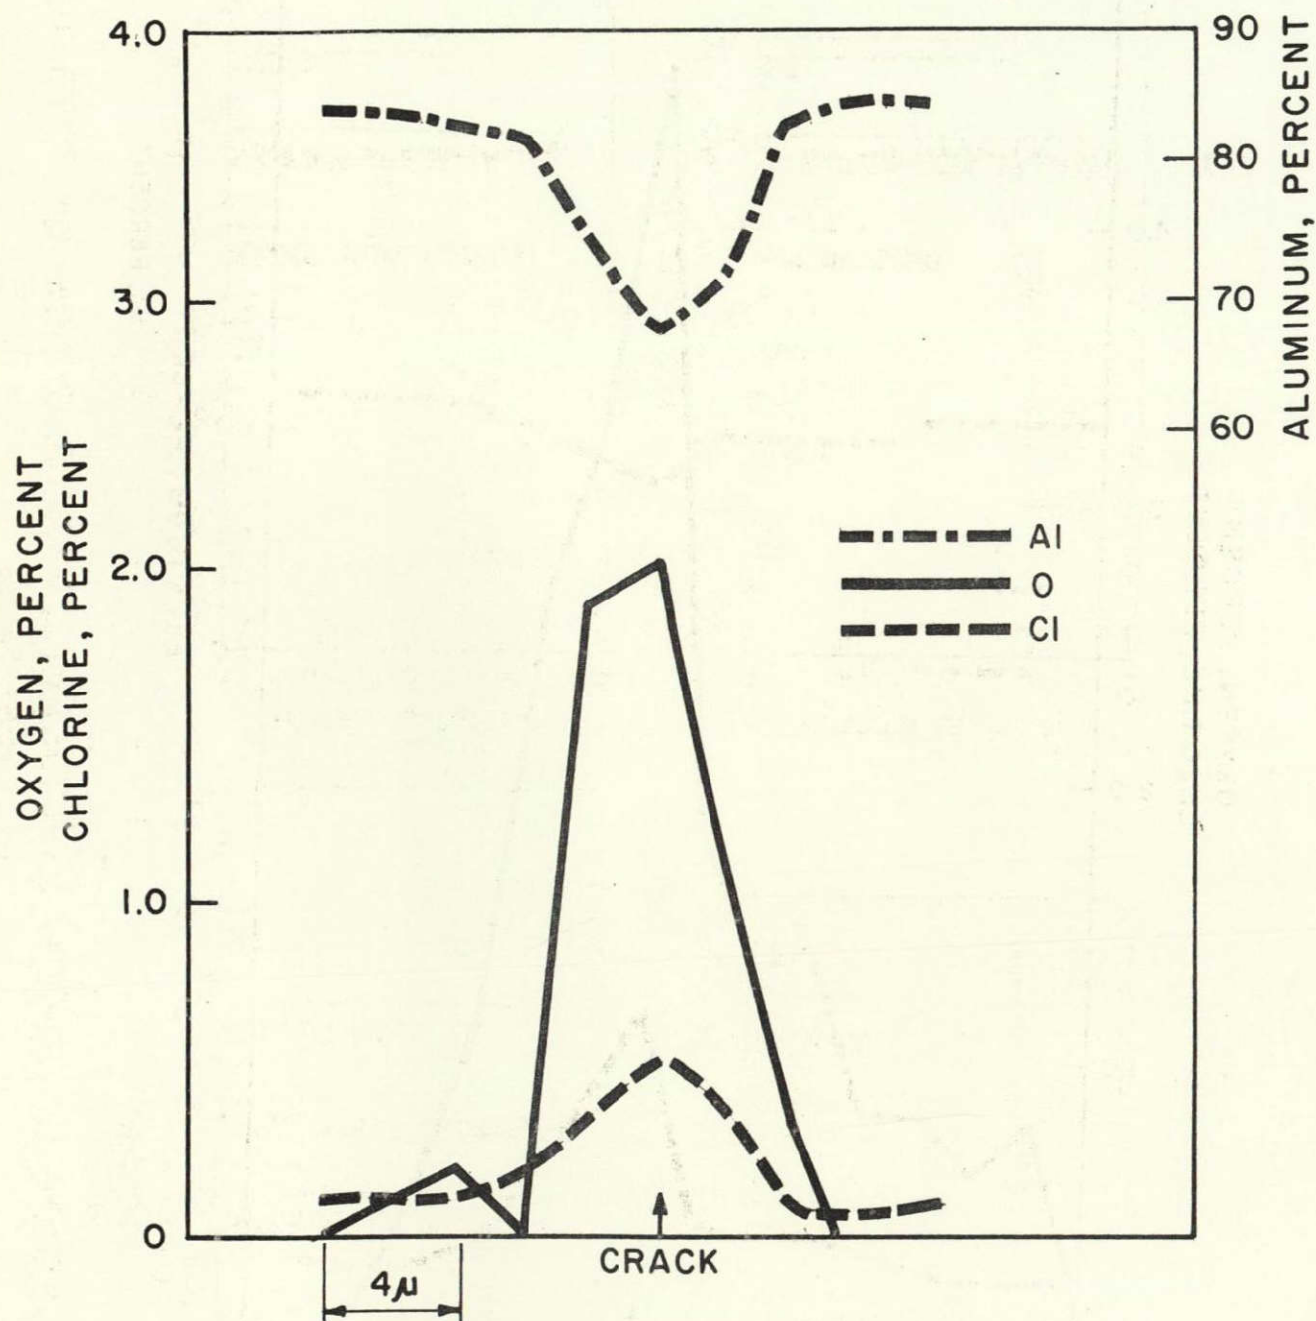
FIGURE 73

DISTRIBUTION OF Al, Cl AND O IN VICINITY  
OF STRESS-CORROSION CRACK

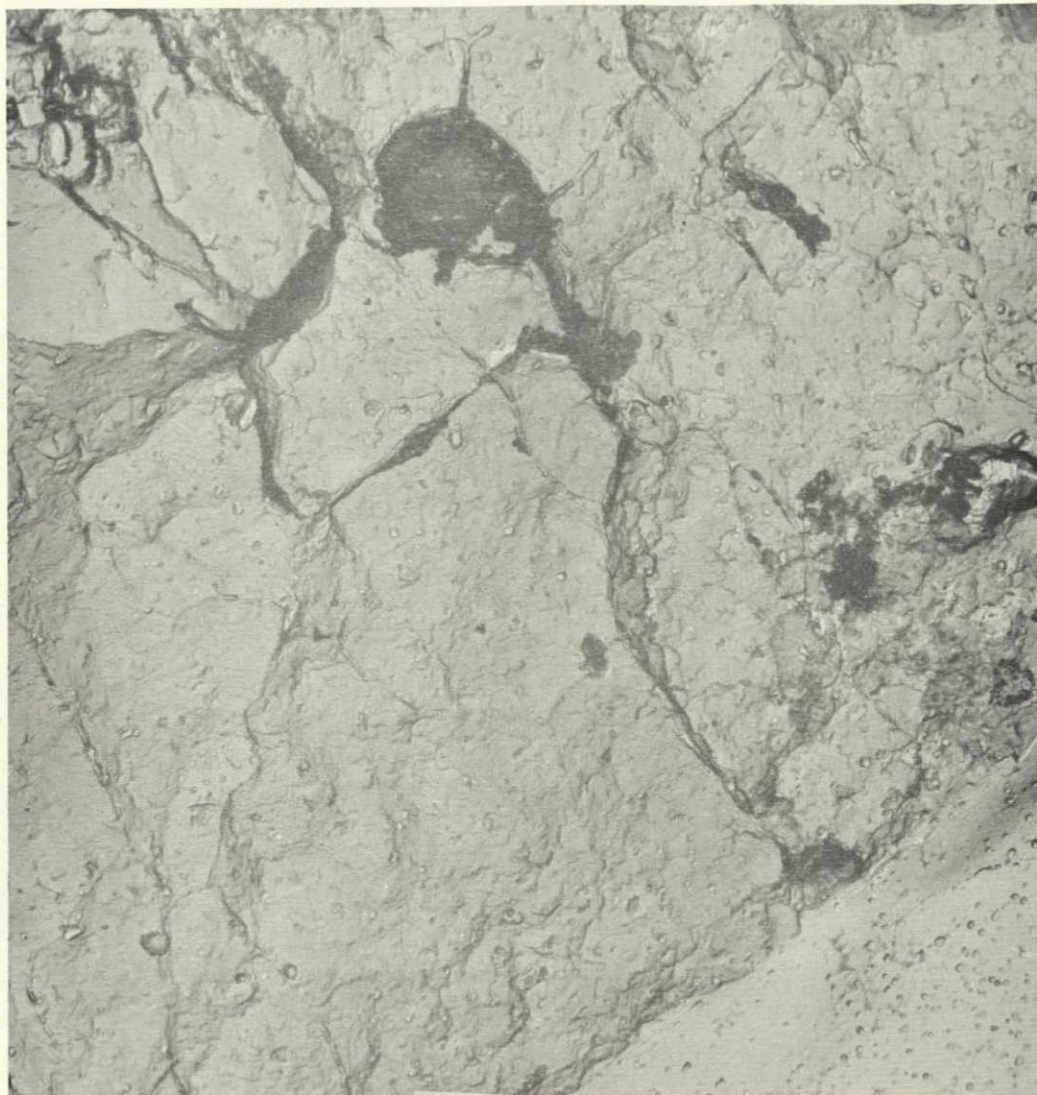
Figure 77

Stress corrosion fracture in 7075-T6 stressed to 75% YS. Stress corrosion proceeded from specimen surface seen at lower right, along polygon boundaries. At the top, a small polygon is almost completely surrounded by stress corrosion cracks. Some corrosion product is seen near the surface at right.

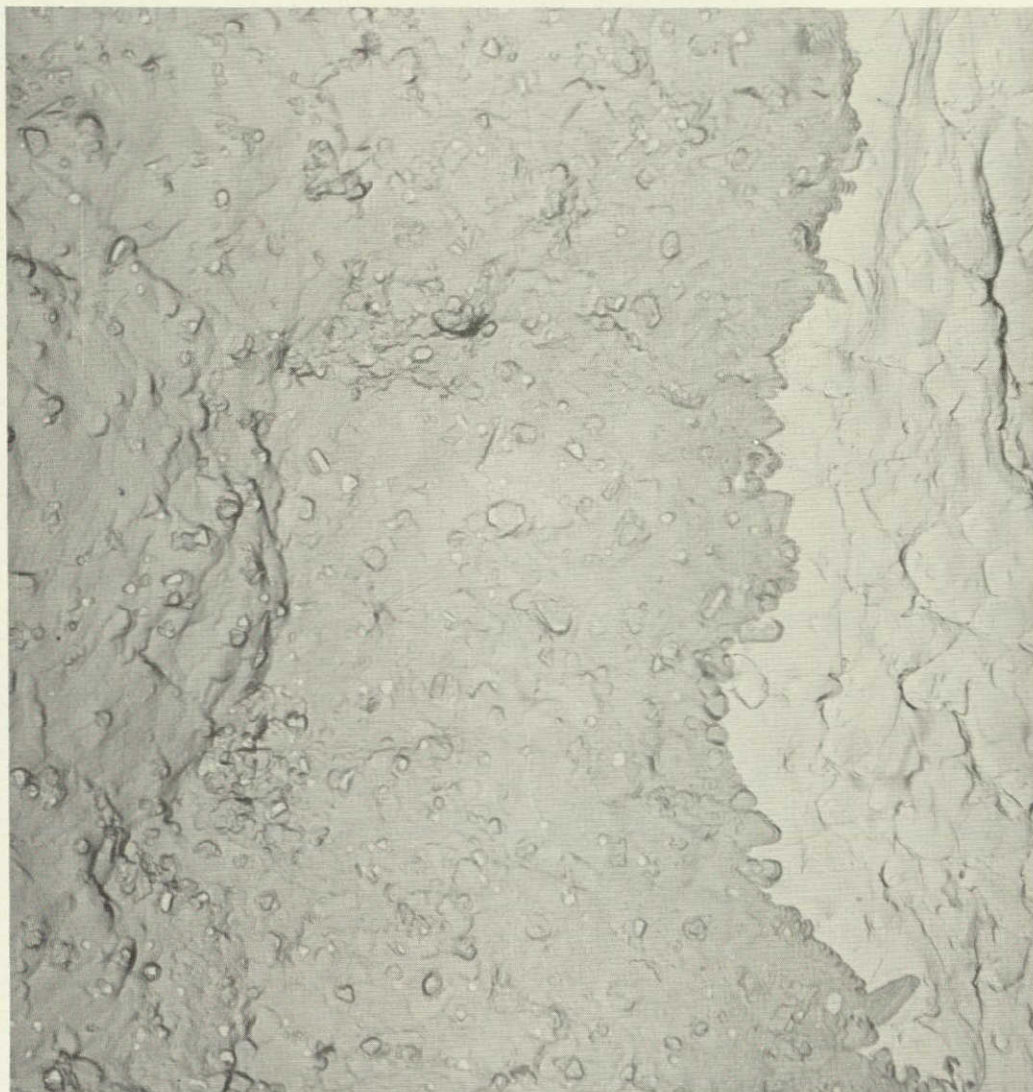
Figure 78

Transition from stress corrosion fracture (left) to tensile fracture showing that tip of stress corrosion crack is irregular. 7075-T6 stressed to 75% YS short transversely.

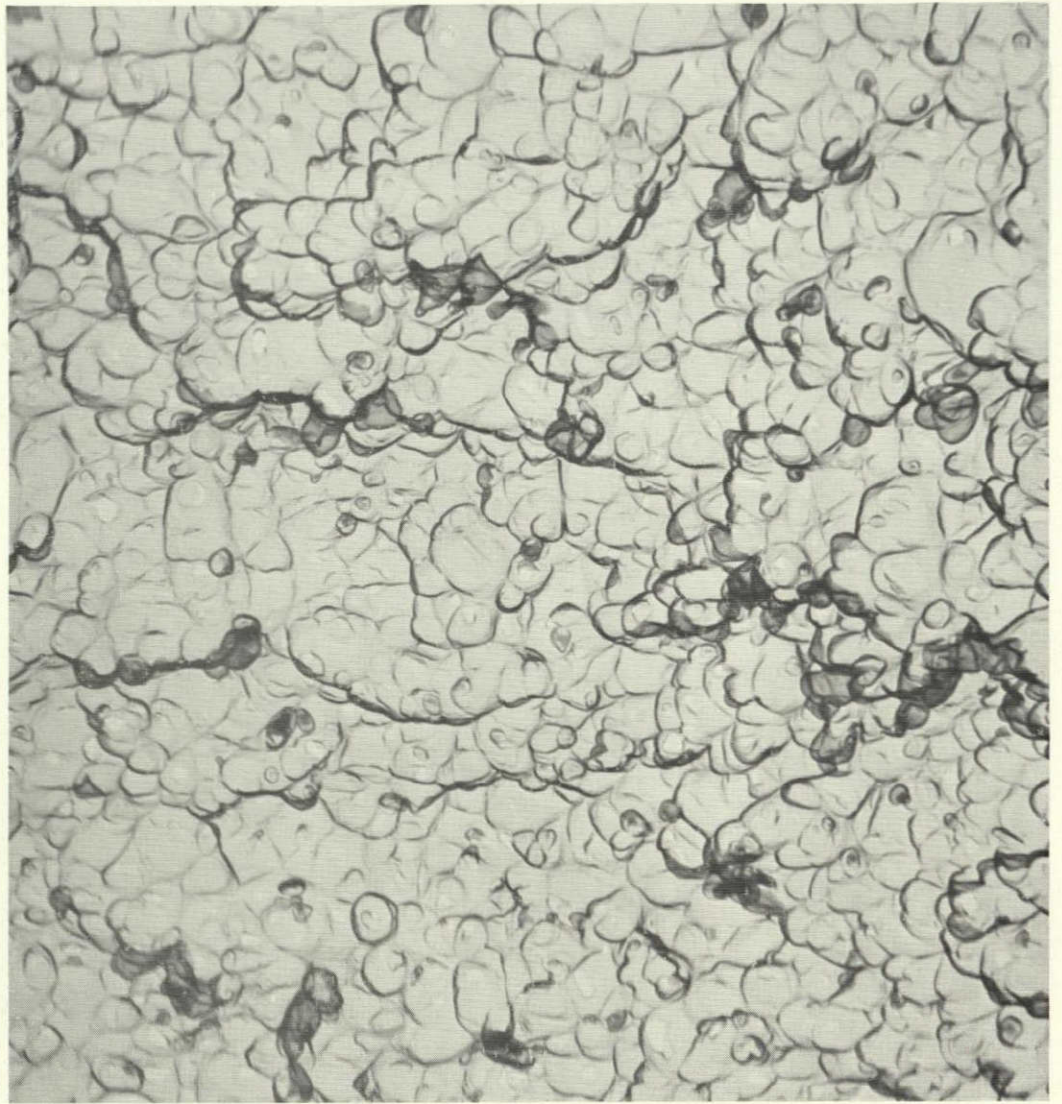
Figure 79

Typical tensile fracture in 7075-T6  
showing small particles associated with dimples.

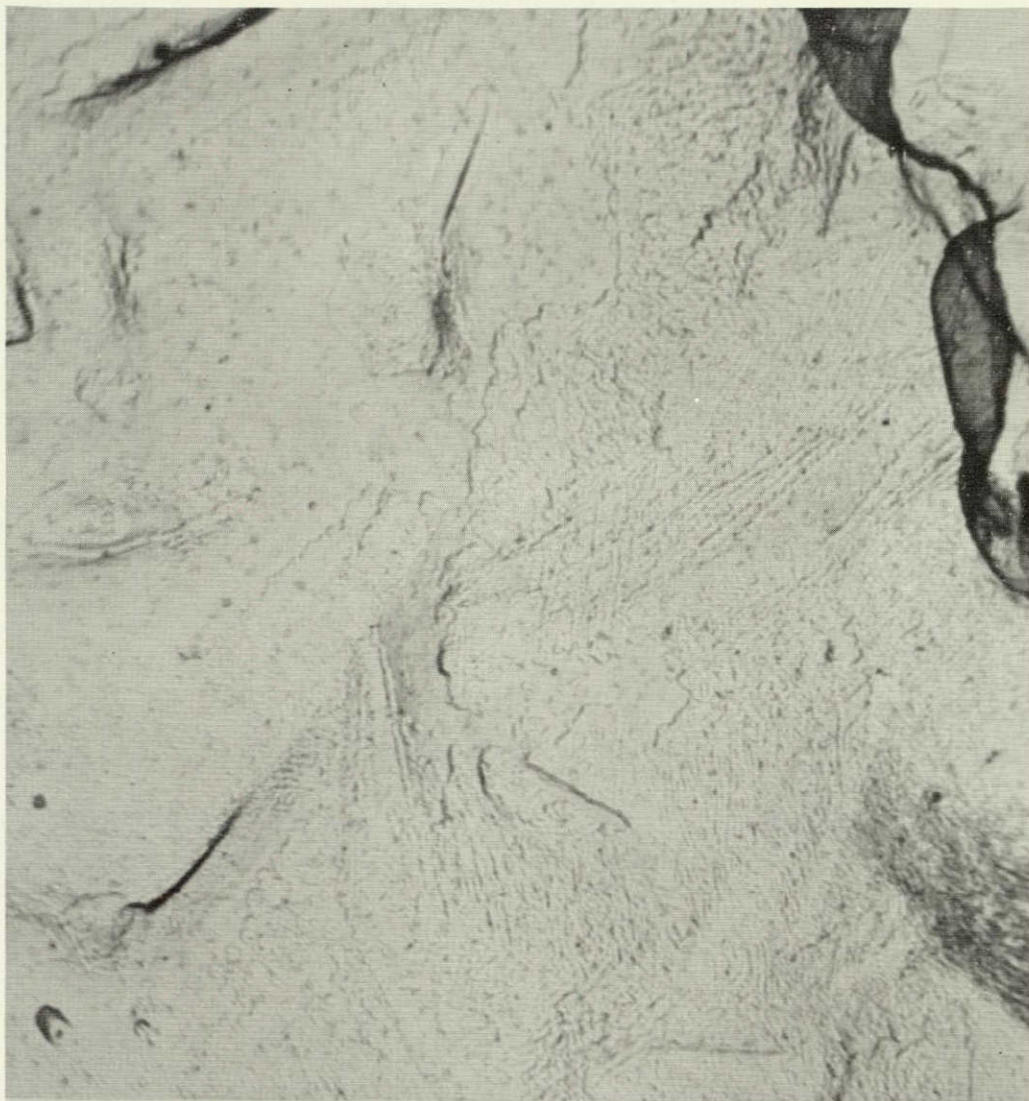
Figure 80

Parallel markings on stress corrosion fracture which might be indicative of plastic deformation. 2219-T37 with S.T. stress of 75% YS.

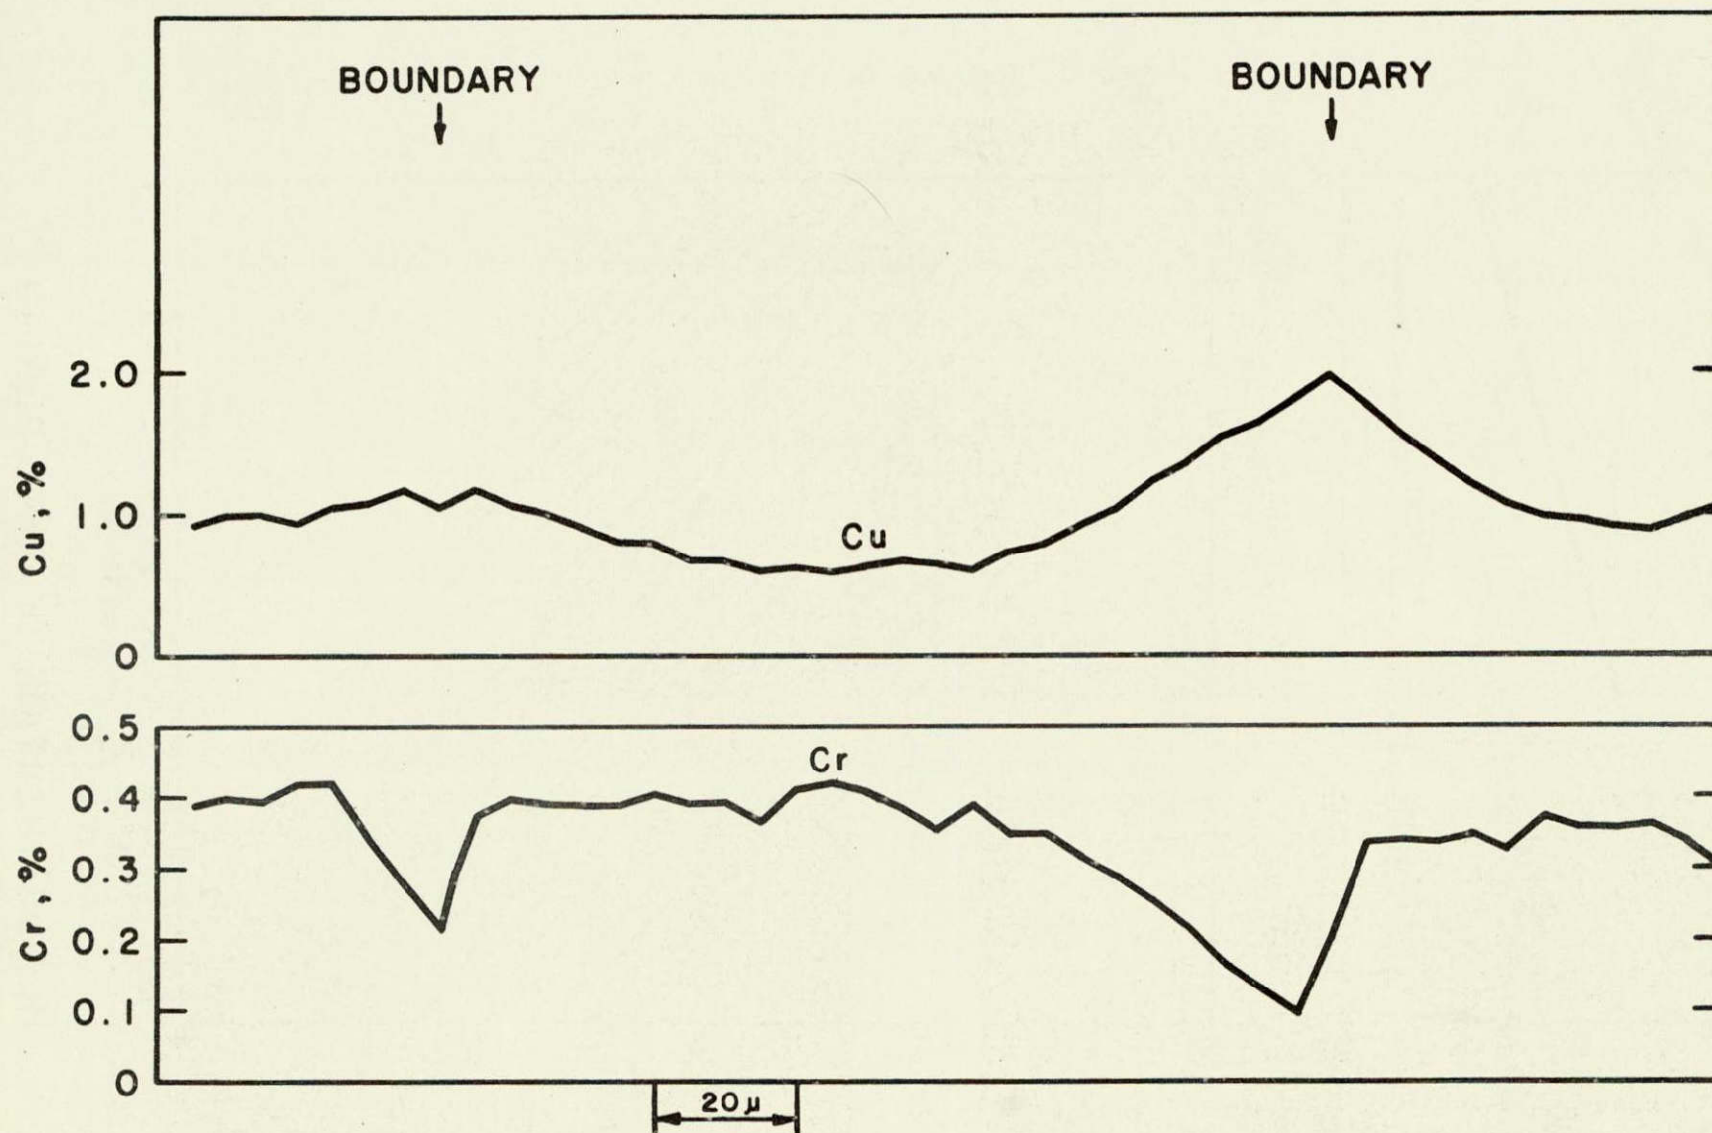
FIGURE 84

VARIATION OF Cu AND Cr ACROSS A DENDRITE CELL IN 7075 ALLOY INGOT SLICE HEAT TREATED TO THE T6 TEMPER.

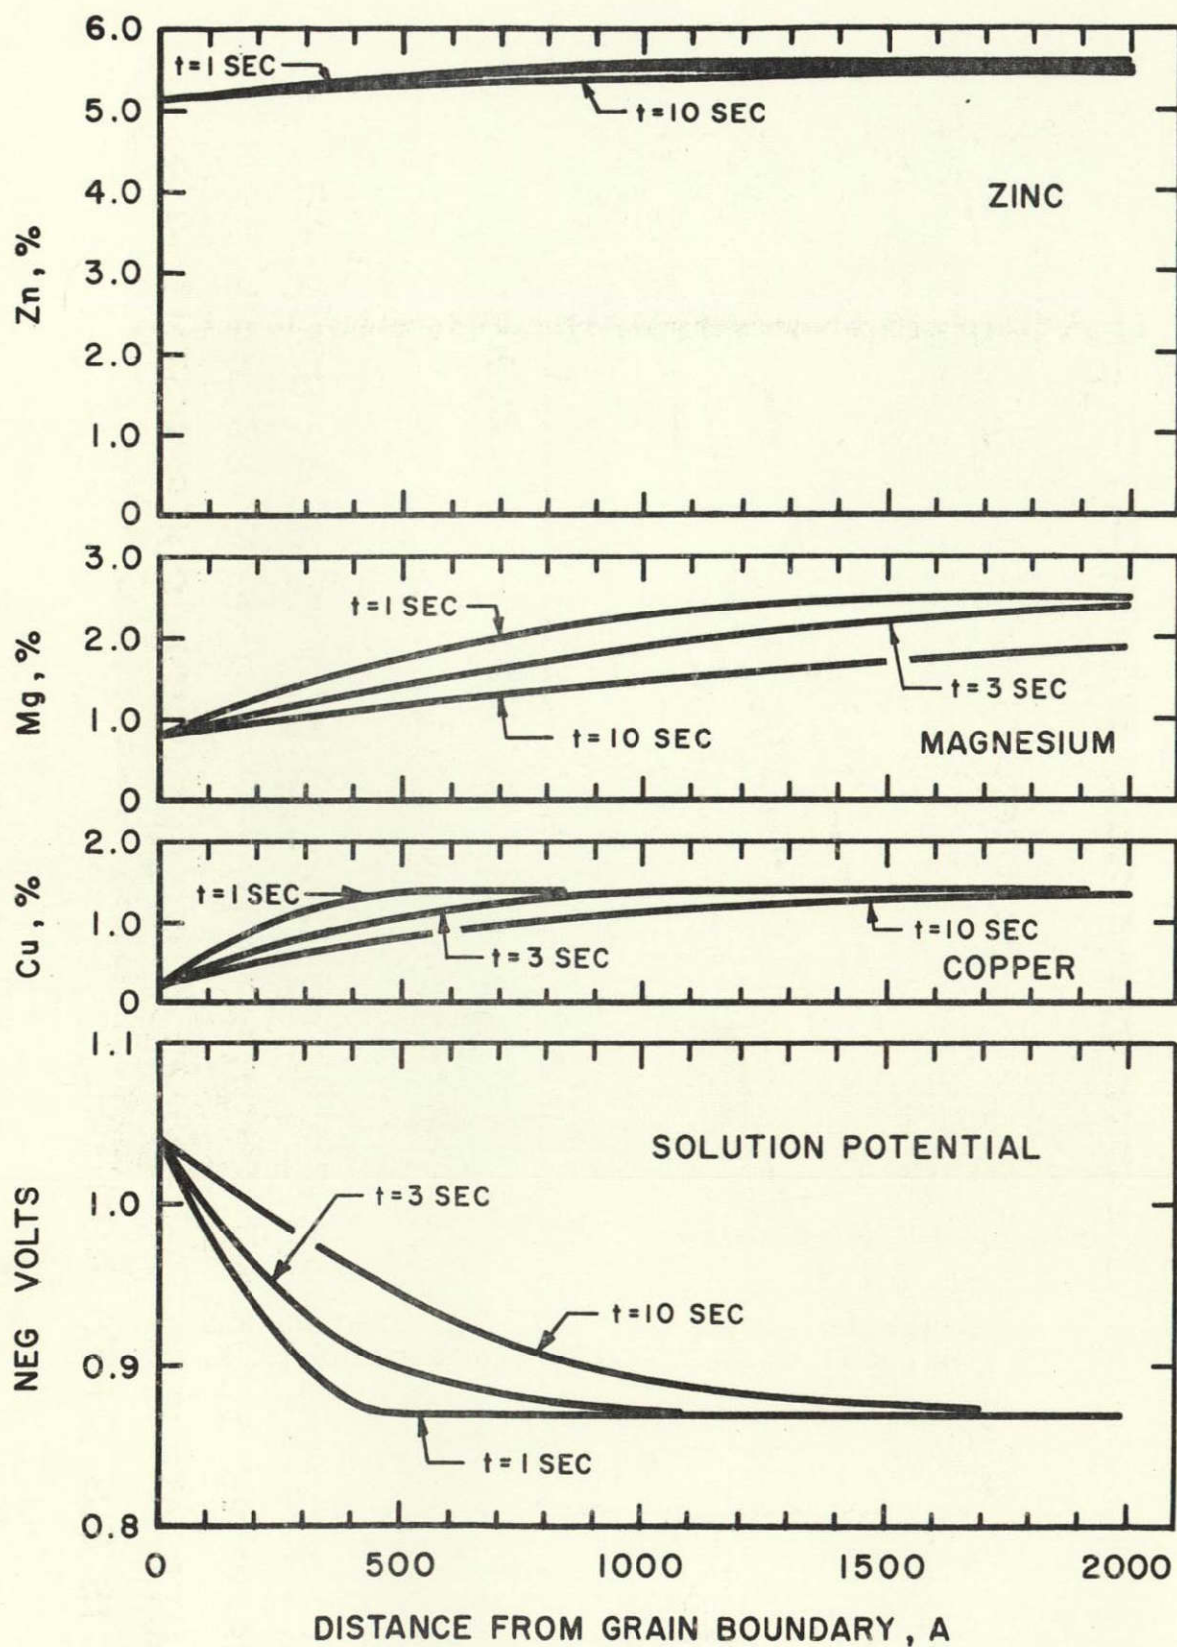
FIGURE 99

CALCULATED GRAIN BOUNDARY GRADIENTS FOR 7075 ALLOY  
 ASSUMING ALLOYING ELEMENT CONTENTS AT BOUNDARY ARE  
 SOLID SOLUBILITIES AT 680 F.

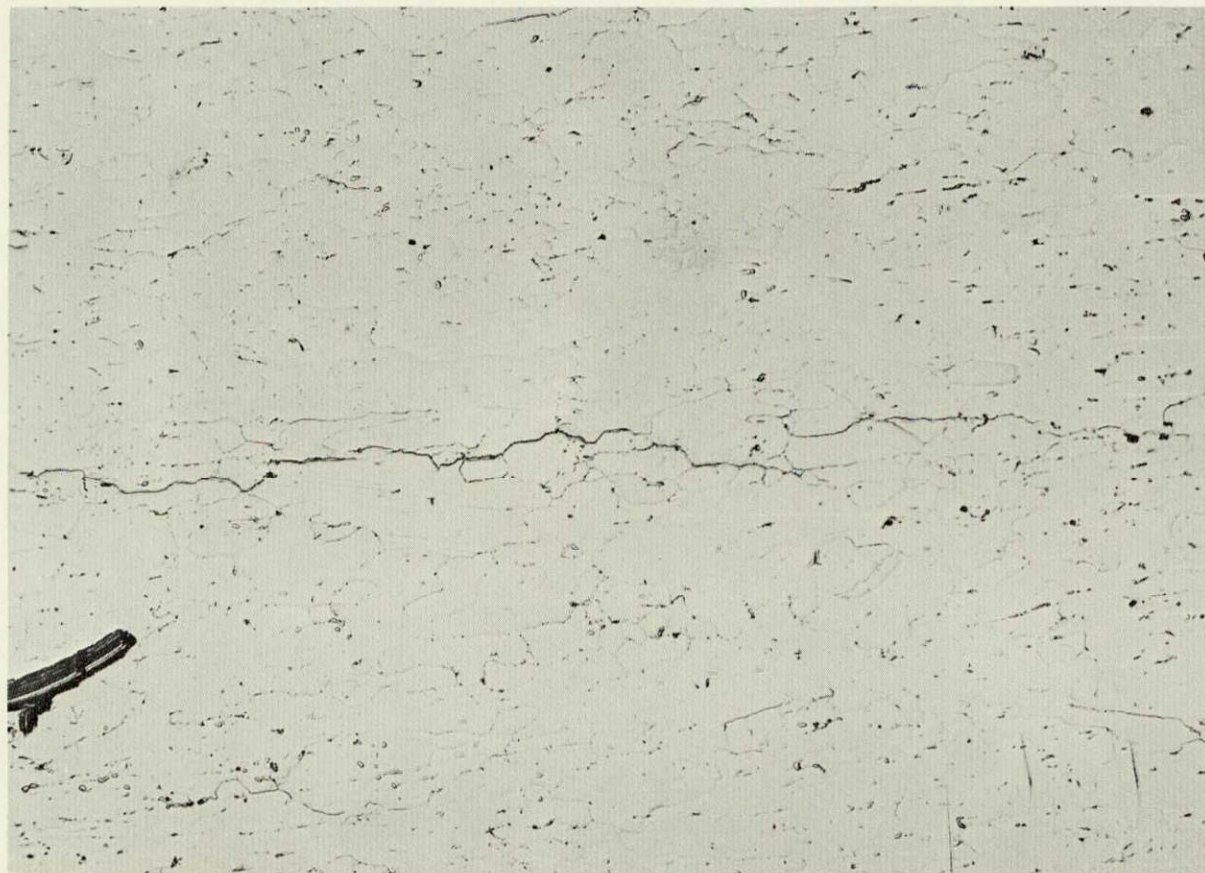
Figure 106

Cracking in 2219-T351 stressed short transversely  
to 90% YS. (X100) Compare with Fig. 46.

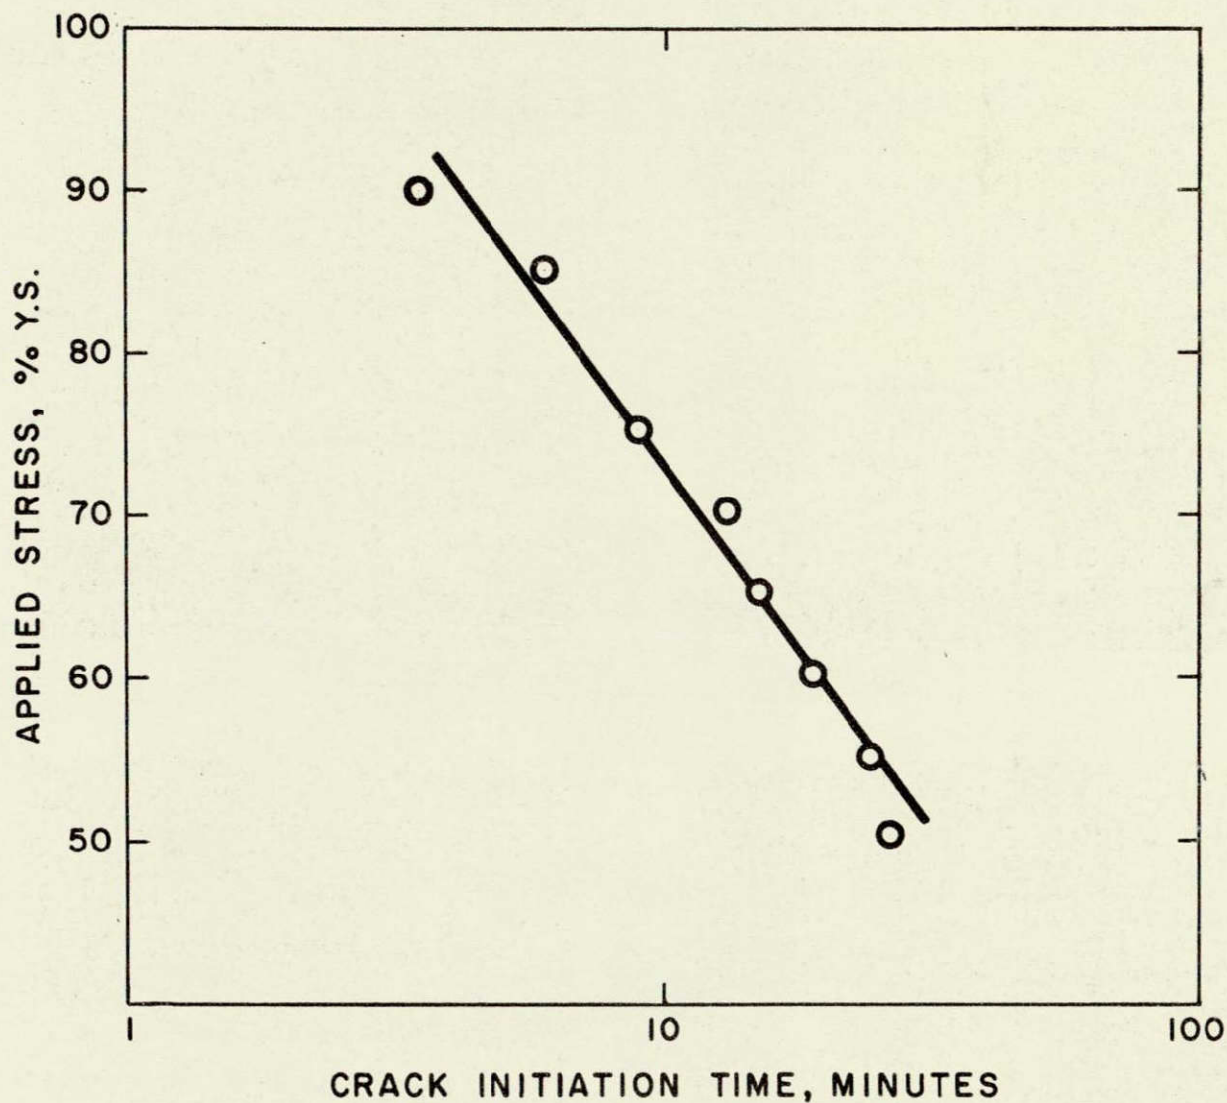
FIGURE 108

RELATION BETWEEN APPLIED STRESS AND CRACK INITIATION TIME WITH 7075-T6 STRESSED SHORT-TRANVERSELY TO 75% Y.S. AND EXPOSED TO  $\text{NaCl}-\text{AlCl}_3$  SOLUTION.

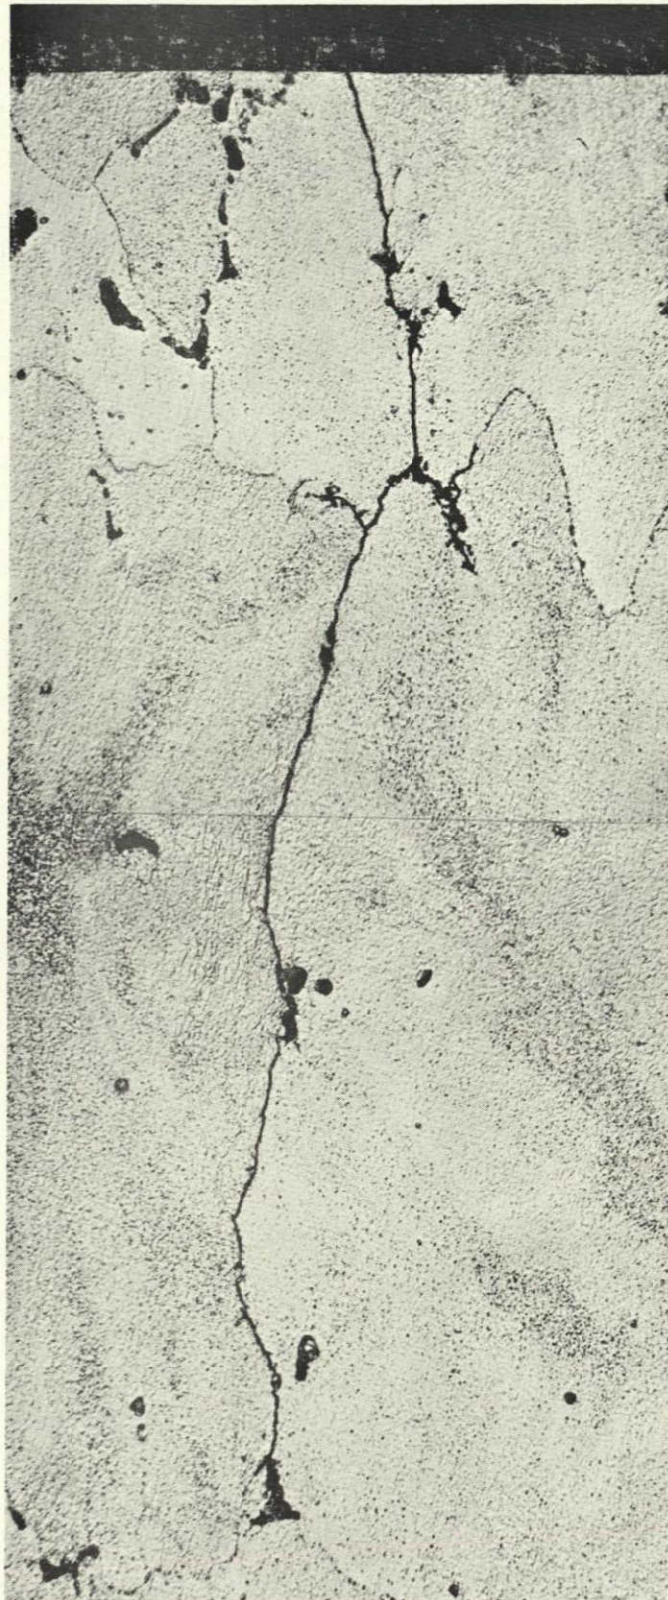
Figure 113

Cross section of sample in Fig. 112  
showing cracks along boundaries. (X500)

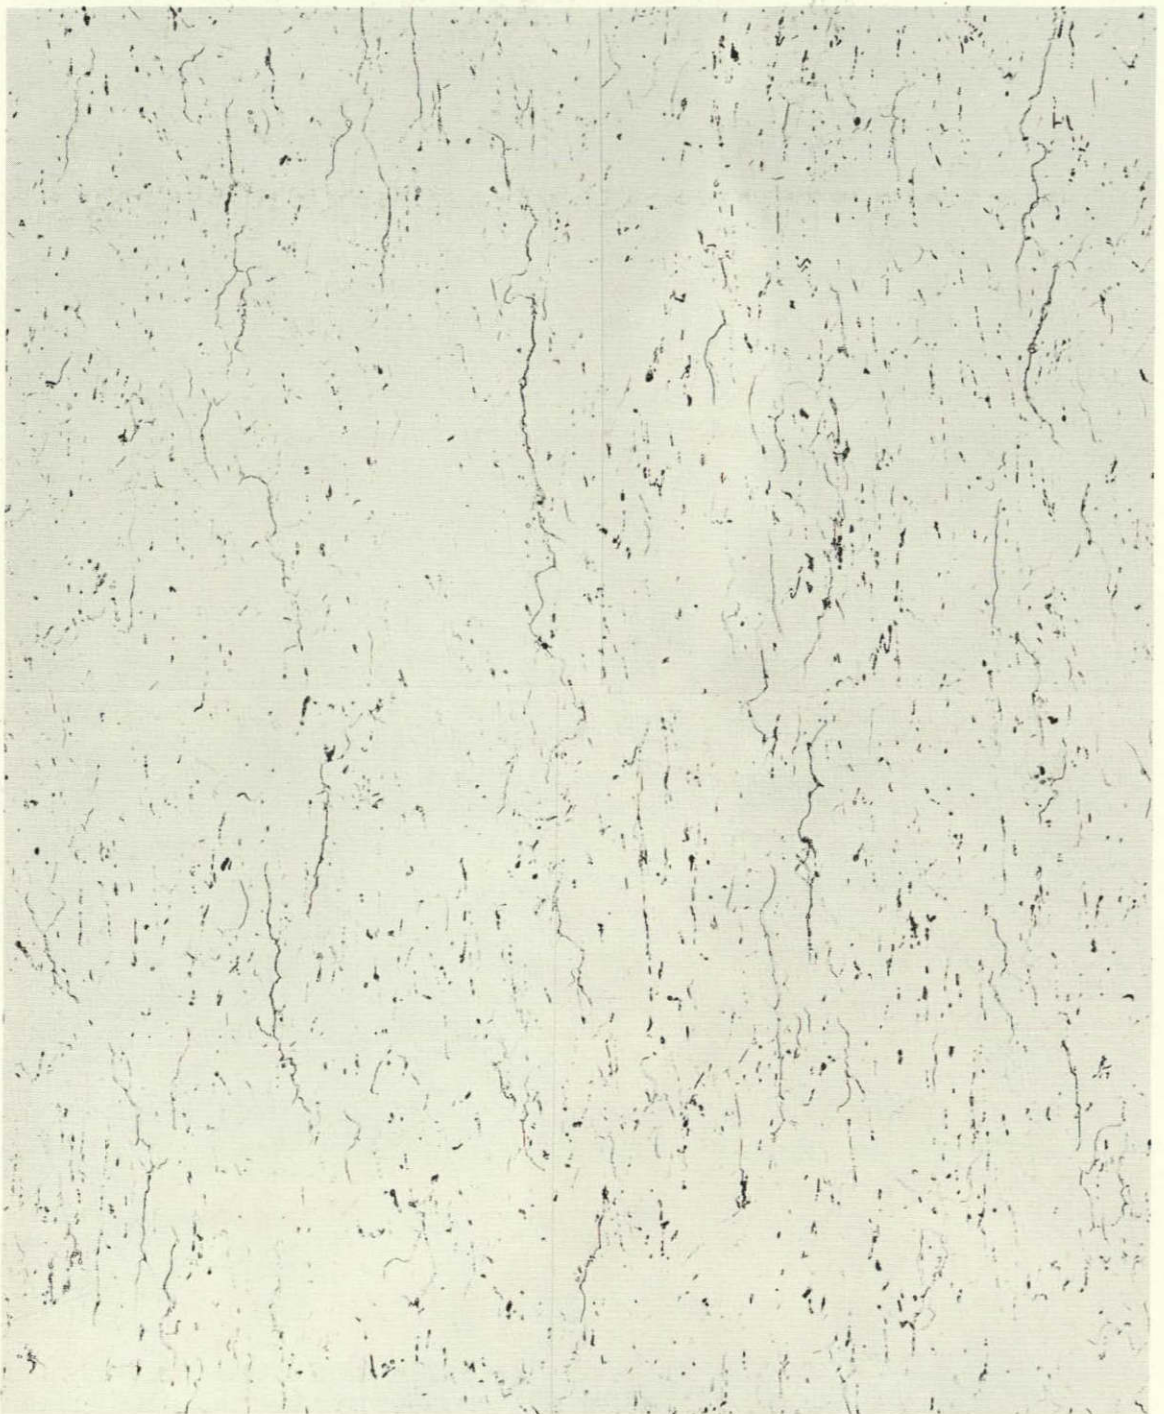
Figure 119

Crack development in 2219-T37 stressed 75% YS  
short transversely (X100). Compare to Fig. 120.

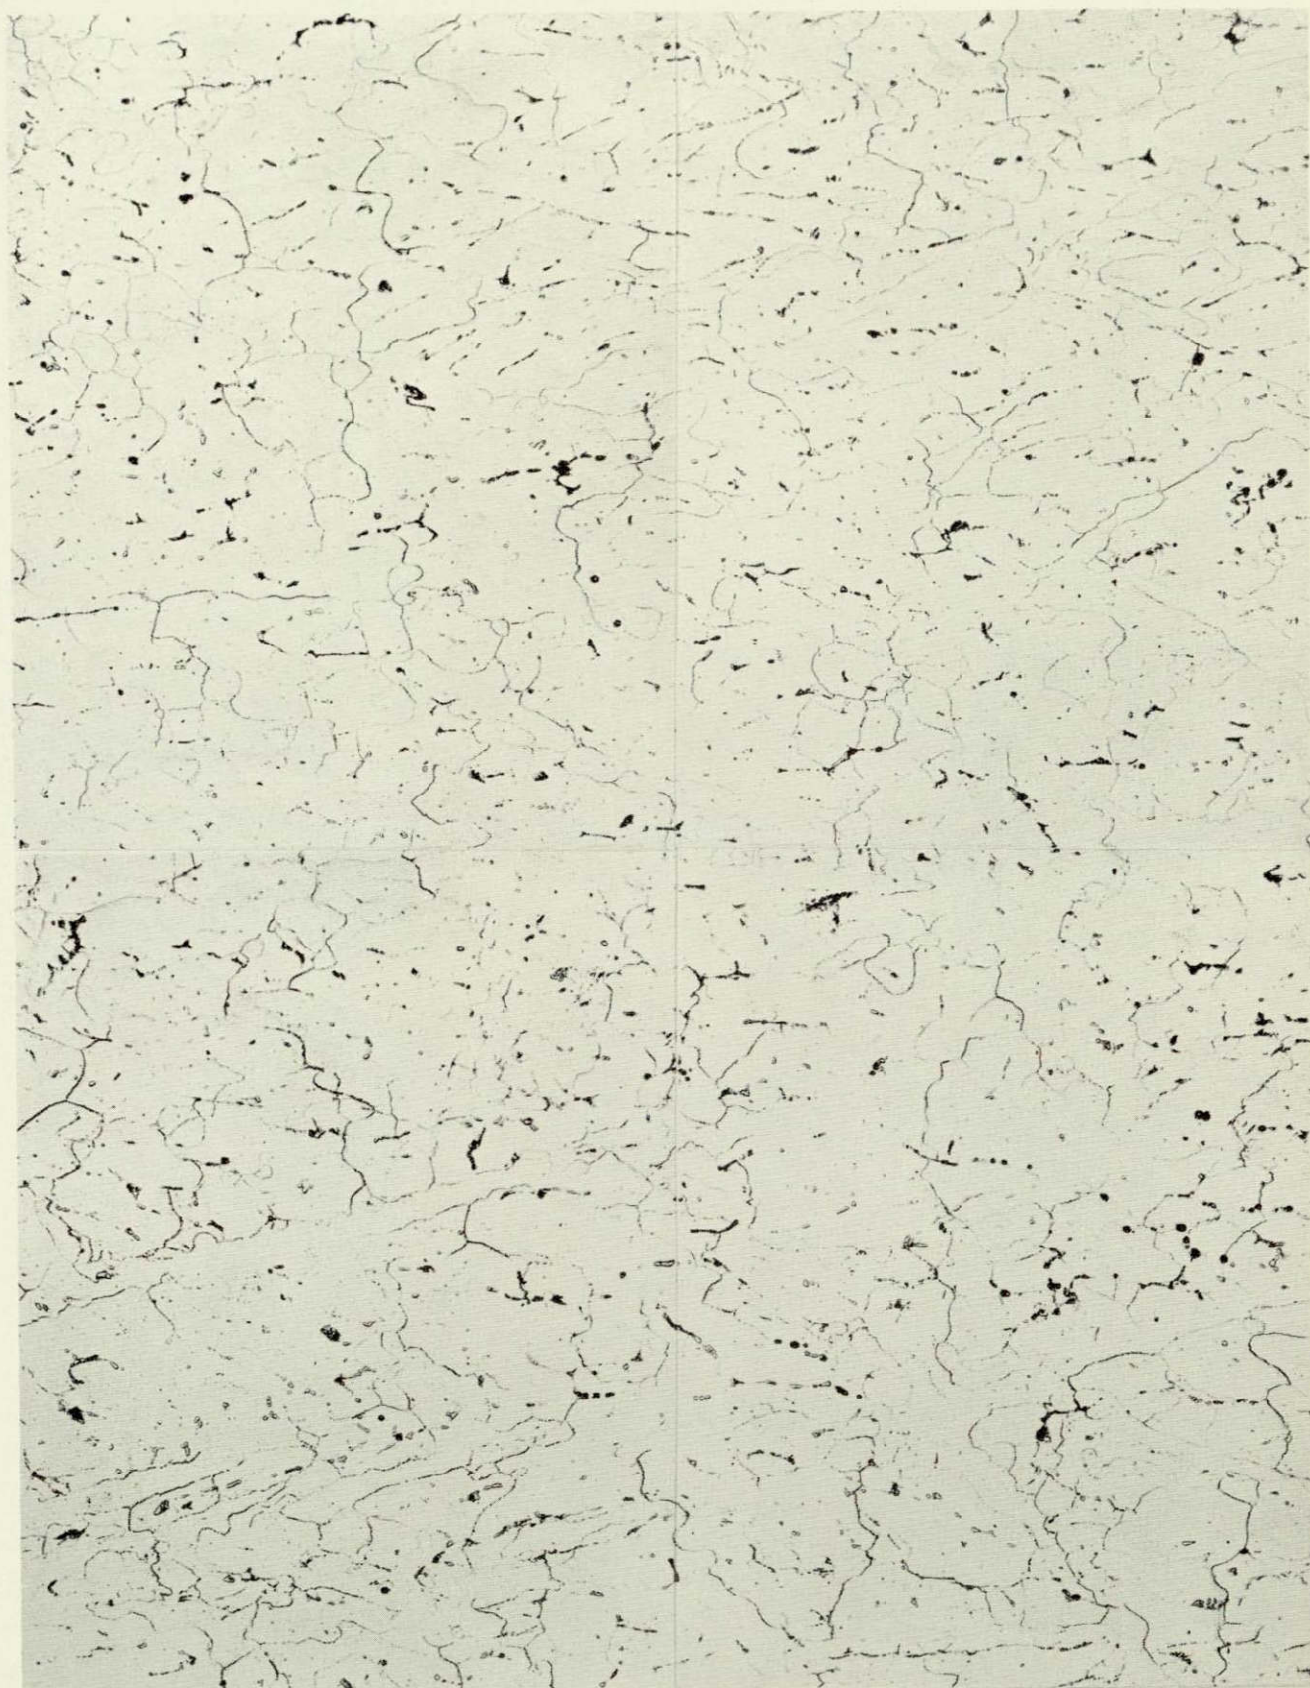
Figure 120

Stress corrosion cracks developed in 25-minute exposure on surface of 2219-T37 specimen stressed longitudinally to 75% YS (X100). Compare to Fig. 119.

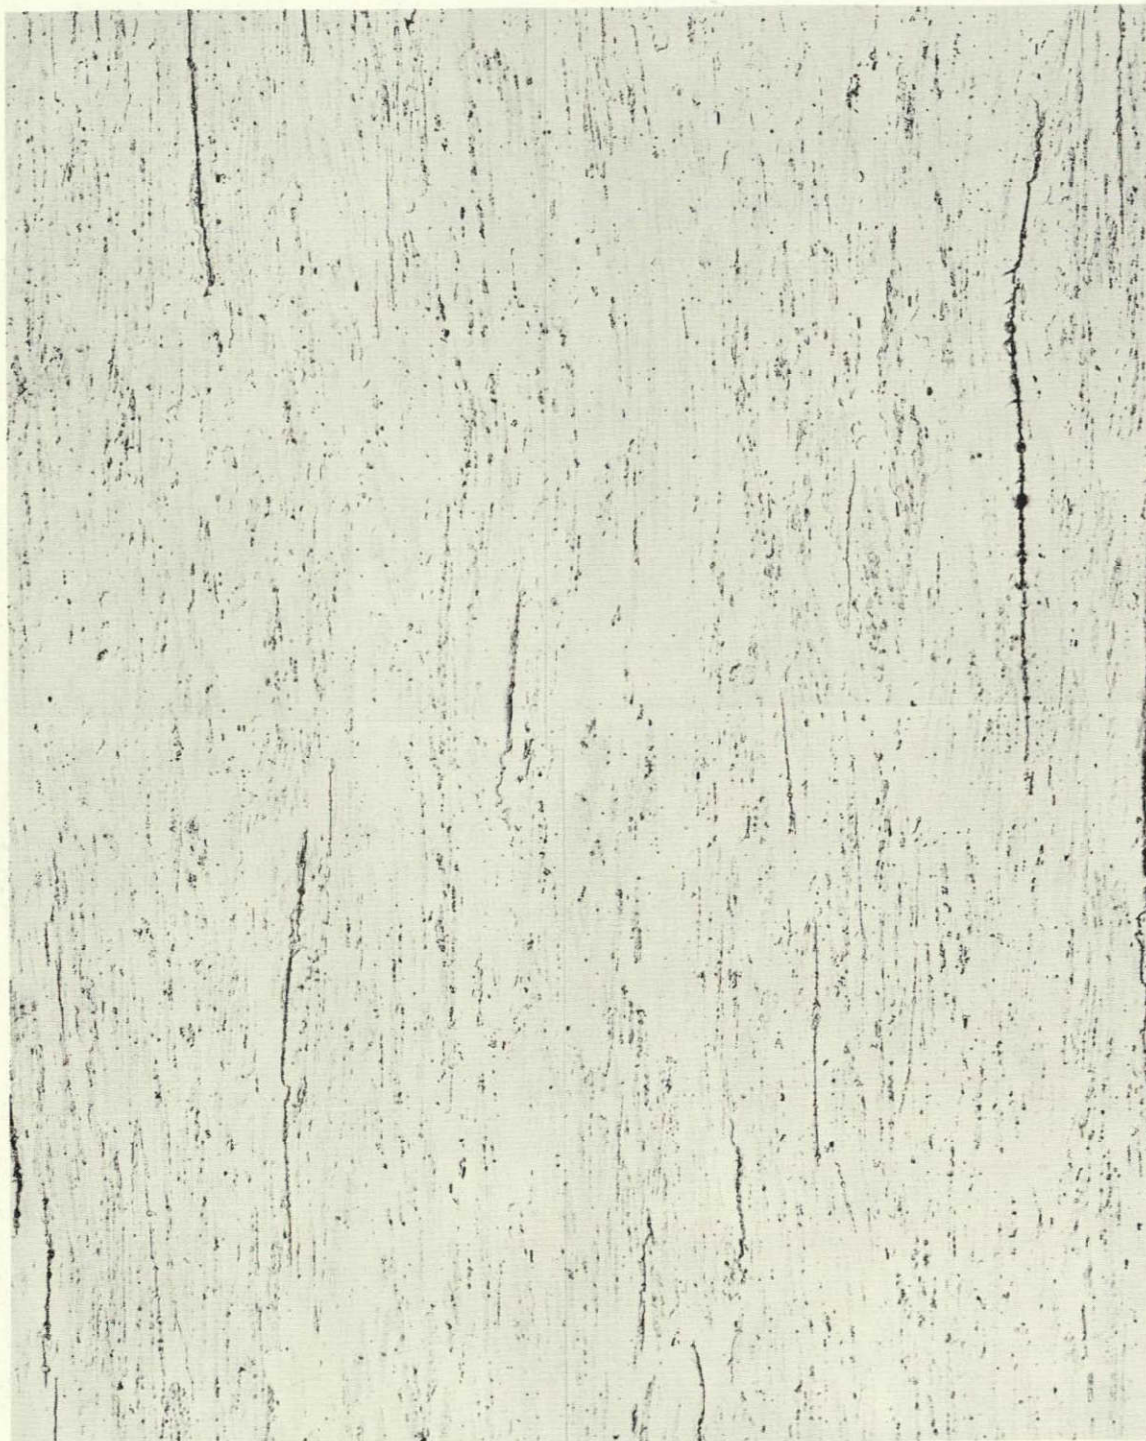
Figure 121

Cracks developed in 7075-T6 stressed 75% YS short  
transversely (100X). Compare to Fig. 122.

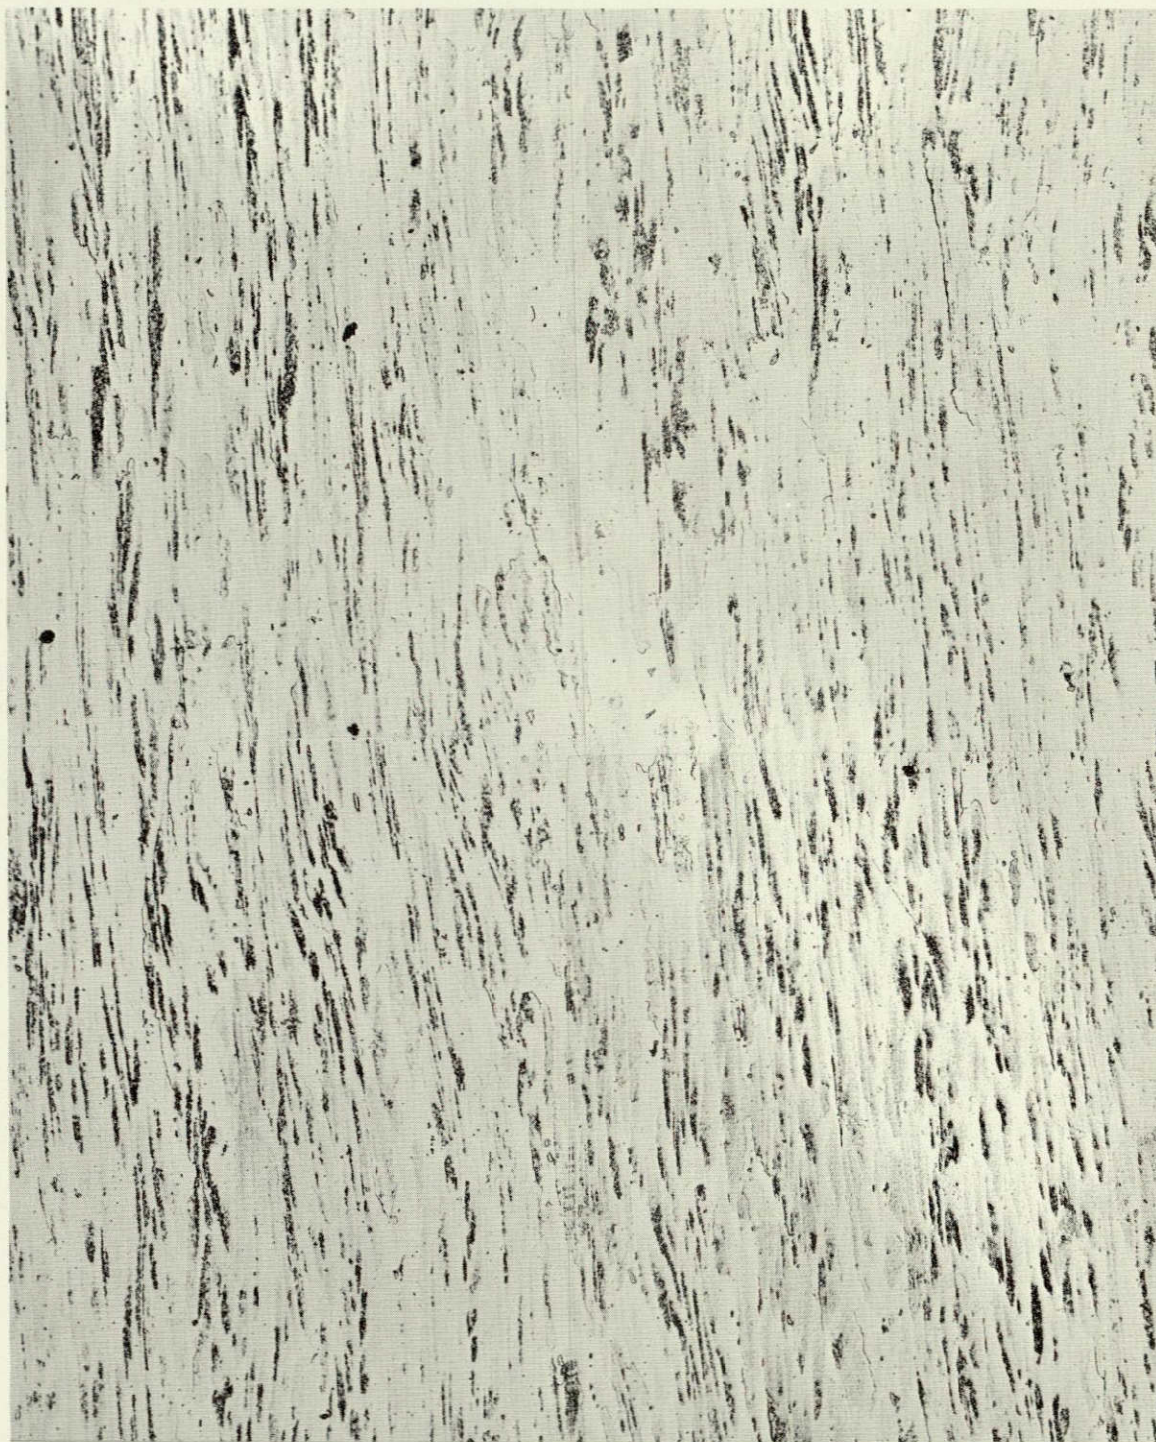
Figure 122

Cracks developed in 7075-T6 stressed 75% YS longitudinally (100X).  
Cracks parallel to stress caused by biaxial stress in specimen.  
Compare with Fig. 121.

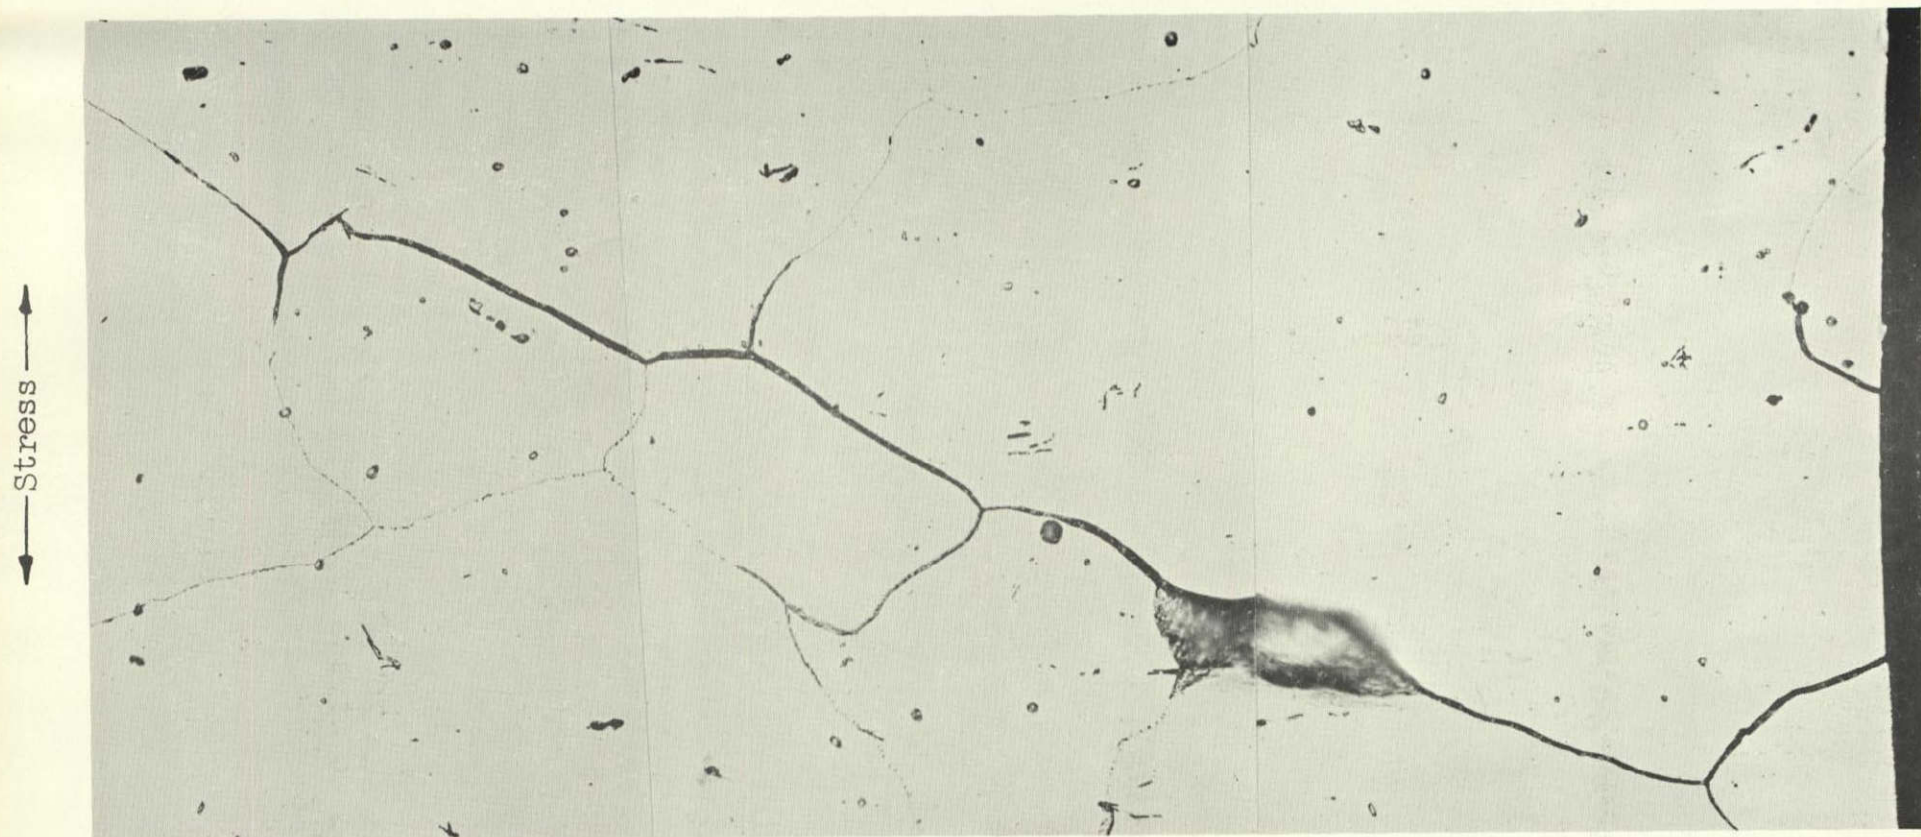
Figure 123

Crack development in X7375-T6 stressed to 75% YS  
short transversely (X500). Compare with Fig. 124.
